ADVANTAGE INSPECTION, INC.

INSPECTION NUMBER # 1122100SS-1

INSPECTION PICTURE ADDENDUM

REPORT # 1122100SS-1

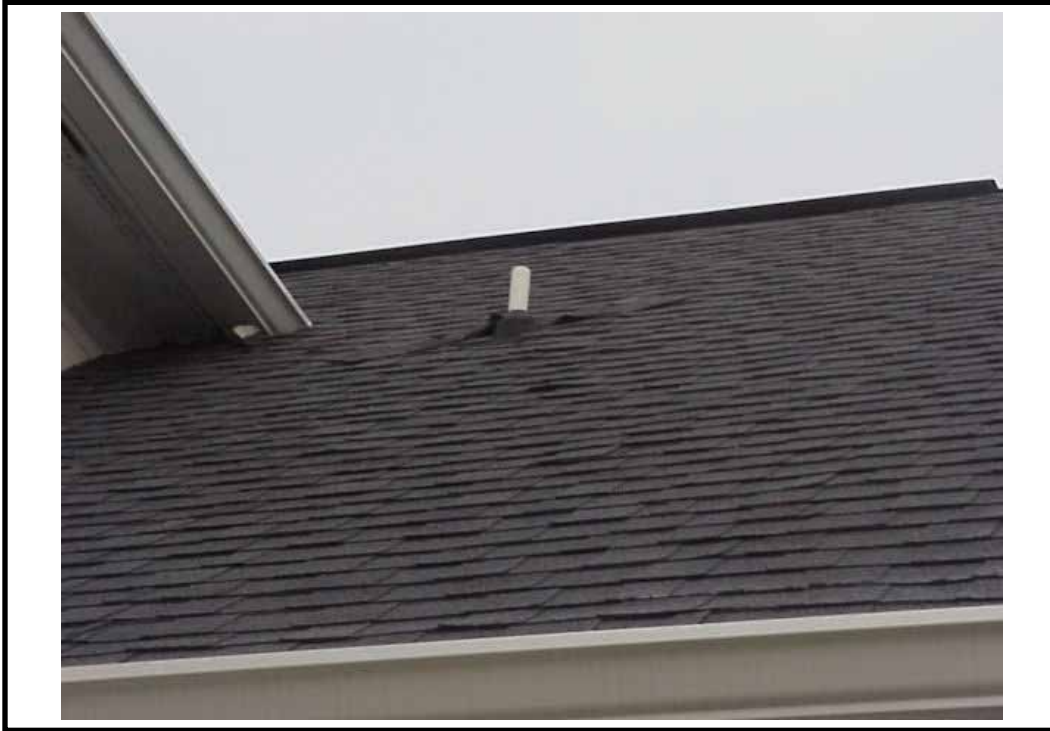
AT LEAST THREE ROOF SHINGLES WERE LOOSE AND NEED TO BE REPLACED ON THE RIGHT REAR OF HOUSE - PROBABLY STORM DAMAGE. SINCE WE INSPECTED FROM THE GROUND AND ATTIC, THE AREAS BEHIND COMPOUND VALLEYS COULD NOT BE INSPECTED. SUGGEST ROOFER EVALUATION WHEN REPAIRS ARE MADE. ROOFER SHOULD ALSO CHECK THE CHIMNEY FLASHING SINCE CLOSE INSPECTION WAS NOT POSSIBLE.

PICTURE OF LOOSE SHINGLE

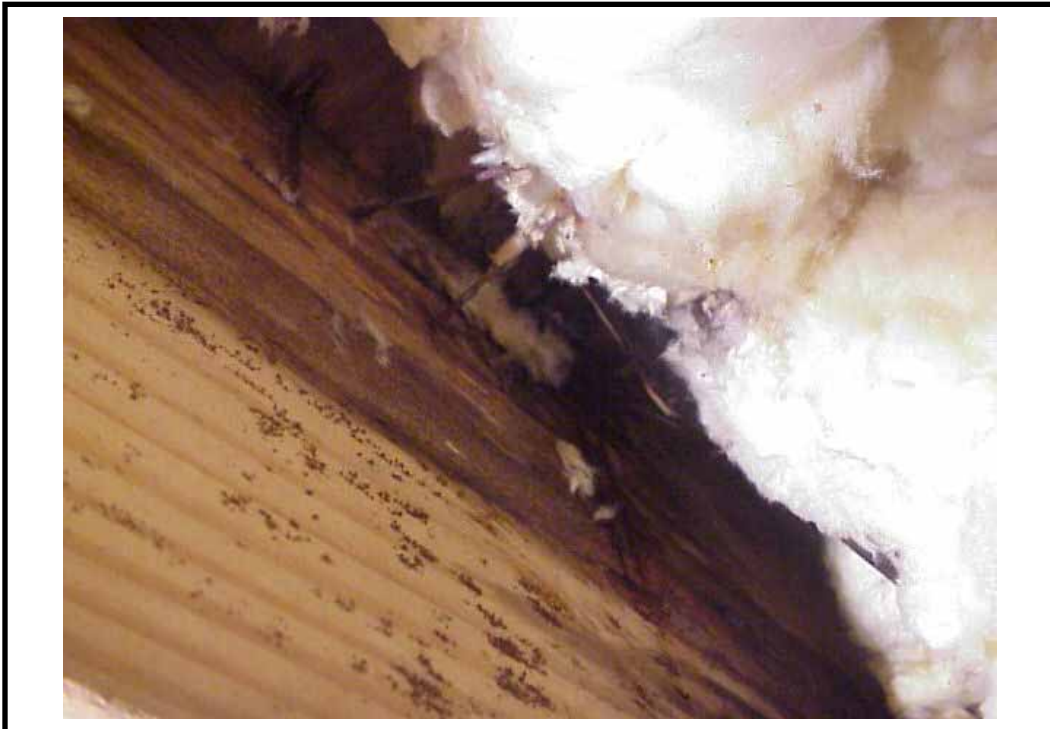
THERE IS A LEAK UNDER THE MASTER BATH SHOWER - APPEARS TO BE COMING FROM AROUND THE ENCLOSURE - HAVE PLUMBER EVALUATE.

PICTURE OF LEAK UNDER THE MASTER BATH SHOWER

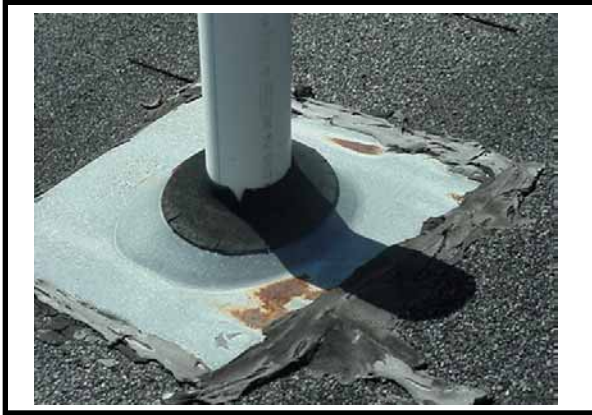
PLUMBING BOOT IS CRACKED AND NEEDS REPLACED.

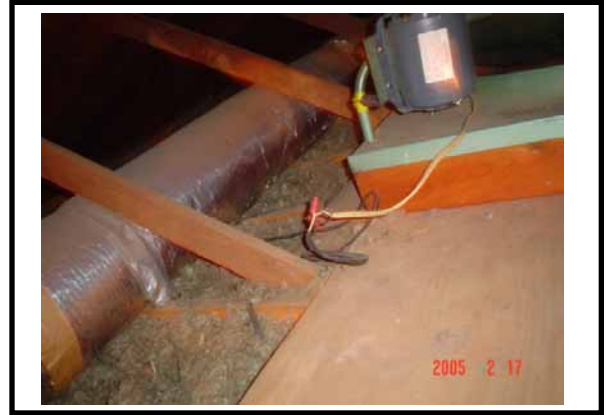
WIRE SPLICE TOWARD REAR OF THE HOUSE NEEDS TO BE PLACED IN A JUNCTION BOX.

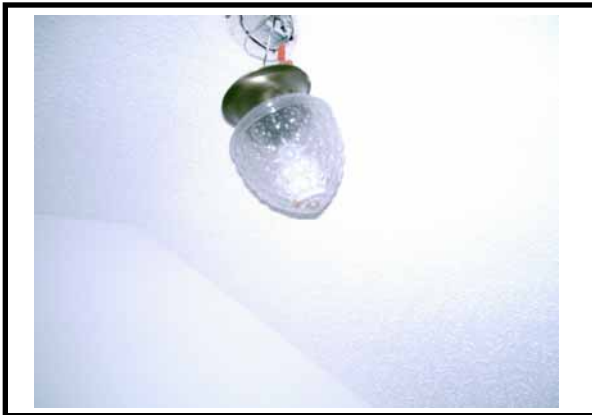
LIGHT FIXTURE IN BONUS ROOM IS NOT ATTACHED TO JUNCTION BOX

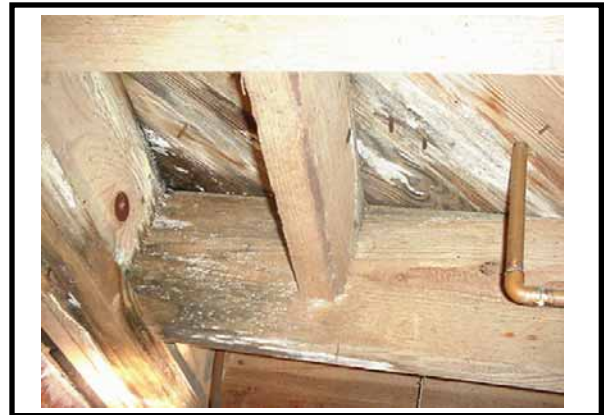
WATER LEAK UNDER MASTER SHOWER NEEDS REPAIR.

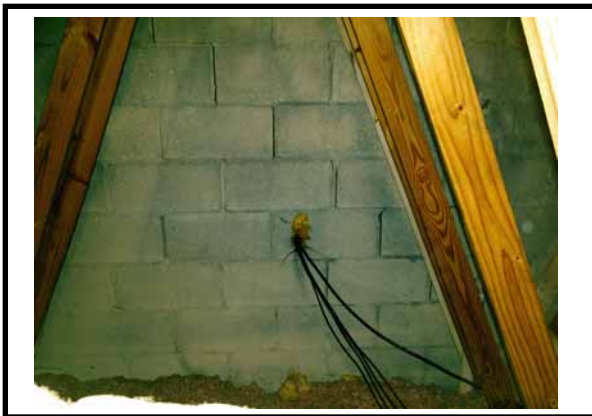
CABLE PASSAGE DRILLED THROUGH CONCRETE WALL IN BASEMENT NEEDS SEALED.

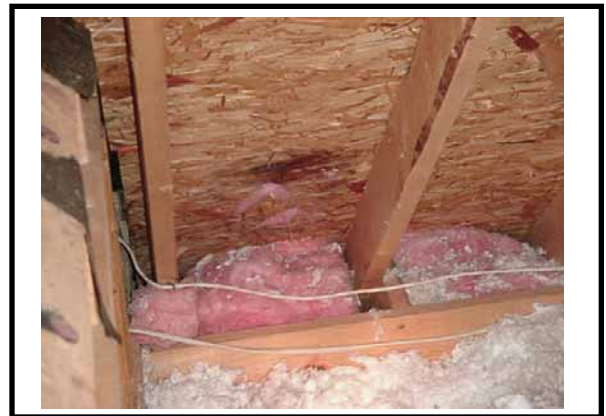
ROOF IS LEAKING IN LEFT REAR SIDE OF HOUSE AND NEEDS REPAIR.
